Cracked but Stable: an Asymptomatic Greater Trochanter Fracture After Bipolar Hemiarthroplasty

Department of Rehabilitation Medicine, Yeouido St. Mary's hospital, College of Medicine, The Catholic University of Korea, Republic of Korea

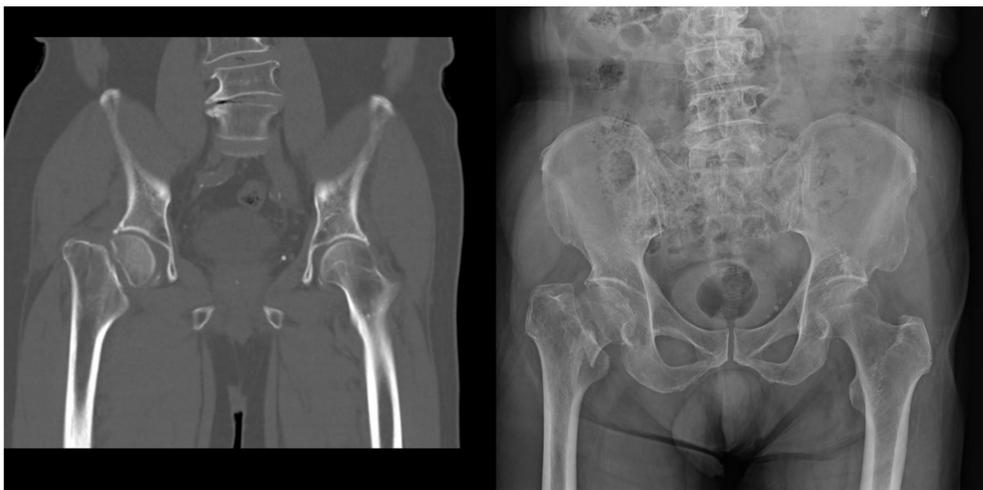
Figure 1. 3D CT image of the pelvic bone and pelvis AP X-ray at the time of emergency department visit.

An 89-year-old male patient presented to the emergency department with right hip pain after a fall. Imaging studies confirmed a right femoral neck fracture, and the patient was admitted to the orthopedic department, where he underwent right bipolar hemiarthroplasty. On postoperative day (POD) 5, the rehabilitation department initiated ambulatory physical therapy, including standing maintenance with a stall bar, strengthening exercises, gentle passive range of motion exercises, stretching, calf pumping, and quadriceps strengthening exercises. On POD 12, he was transferred to the rehabilitation department for more intensive rehabilitation. The patient actively participated in rehabilitation and gaited with a walker in the hospital room. Routine follow-up X-rays were conducted weekly, and on POD 21, a cracked greater trochanter was identified on the right femur. The patient reported no significant change in pain levels. The orthopedic team was consulted again and recommended temporarily holding rehabilitation but did not consider reoperation necessary. The patient was transferred back to the orthopedic department and later discharged. At the POD 3-month follow-up in the rehabilitation outpatient clinic, the patient gaited using a quad cane, reporting still minimal pain. However, imaging revealed the cracked greater trochanter had progressed to a complete fracture with displacement. The orthopedic team continued to recommend observation without surgical intervention.

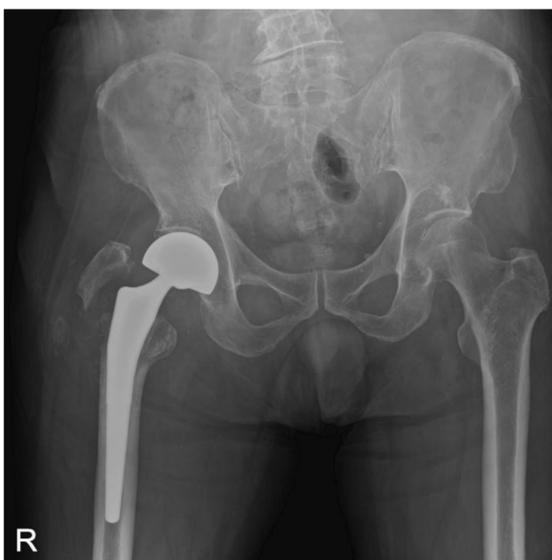
Figure 3. Both hips AP X-ray at POD 3 months

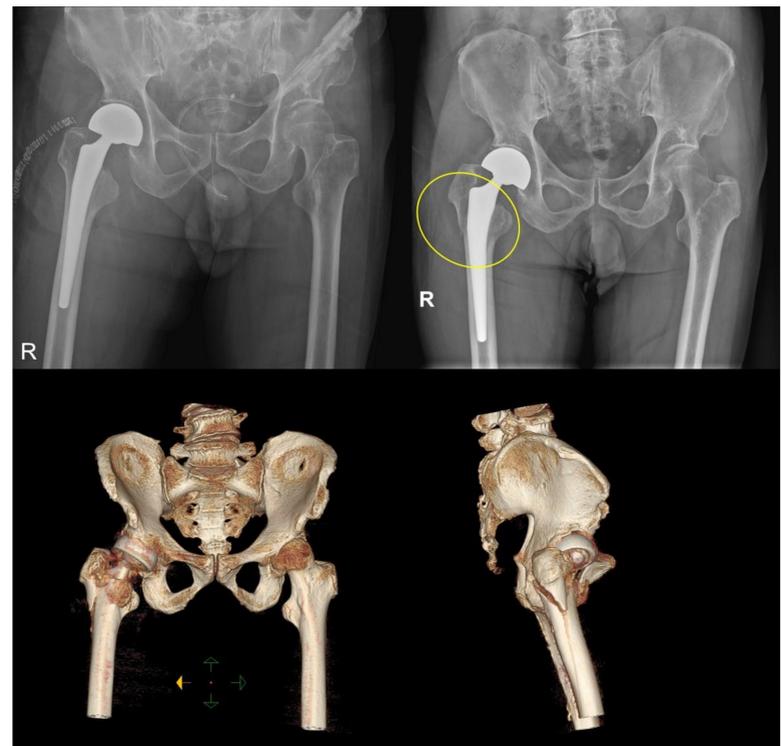
Figure 2. Both hips AP X-ray immediately after surgery and on POD 21 (top row), and 3D CT image of the pelvic bone on POD 21 (bottom row)
