## **Cauda Equina Syndrome by Disc Herniation with Posterior Limbus Vertebra : A Case report**

Aeri Jang<sup>1\*</sup>, Junhee Lee<sup>1</sup>, Yongjae Cho<sup>2</sup>, Hasuk Bae<sup>1†</sup>

Ewha Womans University, Department of Rehabilitation Medicine<sup>1</sup>, Ewha Womans University, Department of Neurosurgery<sup>2</sup>

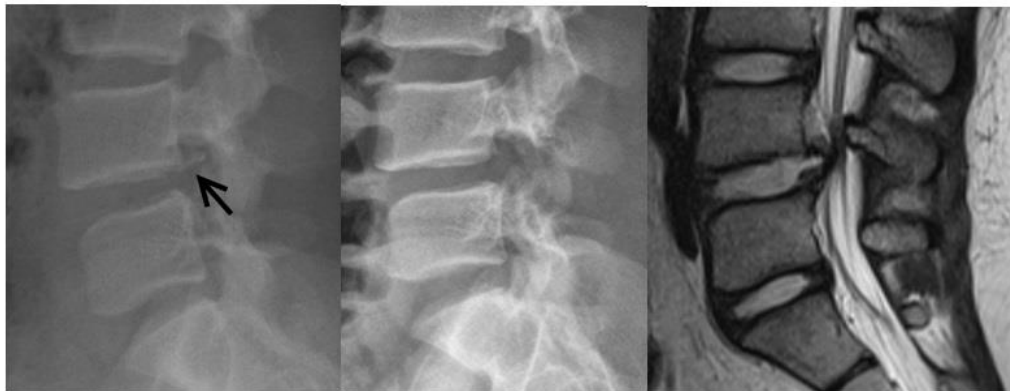
Figure 1. Pre-operative plain radiography (arrow; a small segment of limbus vertebra), Post-operative plain radiography, Pre-operative T2-weighted magnetic resonance image.
